**EXPLORATORY DEVELOPMENT OF
AN OVERHAUL COATING PROCESS
FOR GAS TURBINE COMPONENTS**

Detroit Diesel Allison
Division of General Motors Corporation

TECHNICAL REPORT AFML-TR-78-84

Final Report for Period May 1976 to March 1978

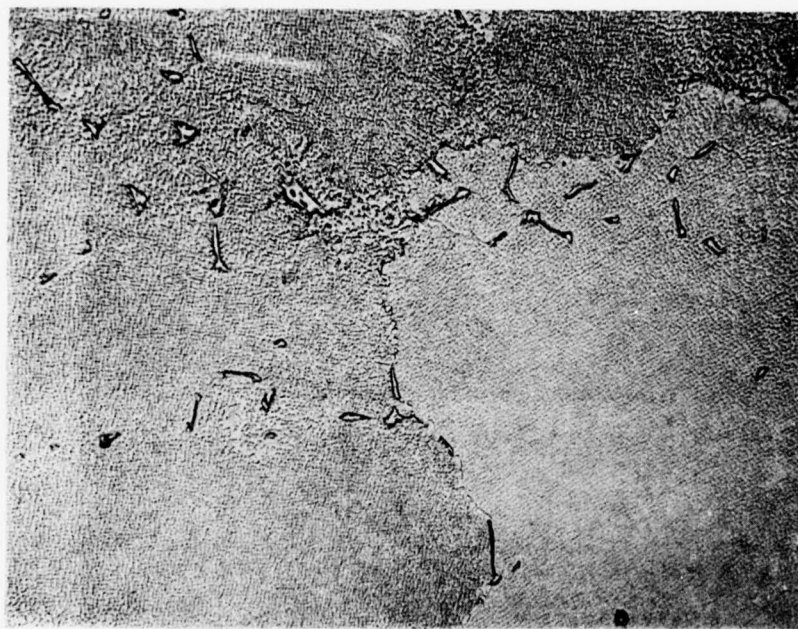
Figure 3-2 PWA 73 coated B1900 alloy - cylindrical cast test specimens (500X)

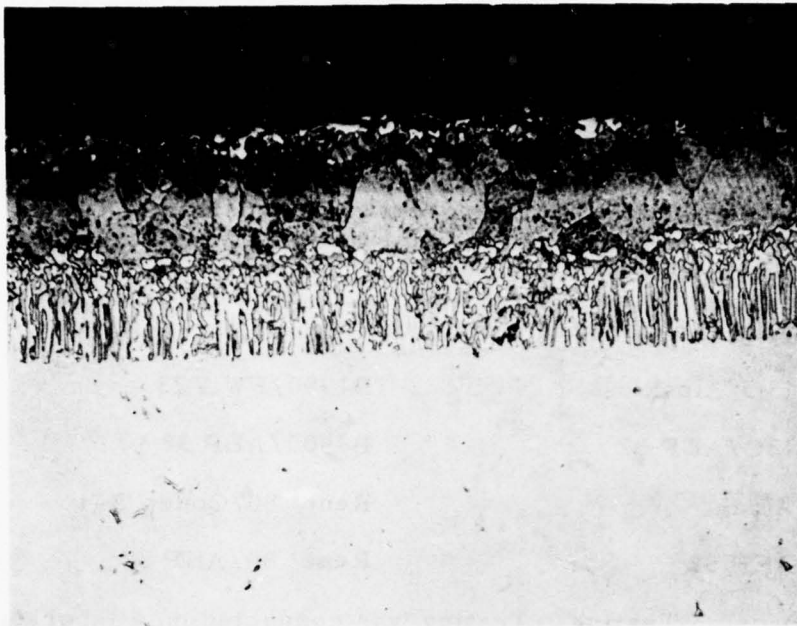
Figure 3-8 AEP 32 coated C1023 alloy - cylindrical cast test specimens (500X)

- AEP 32 Coating Structure on Various Program Alloys Figures 3-5a through 3-8 show representative structures of the base material and AEP 32 coatings on the program alloys.

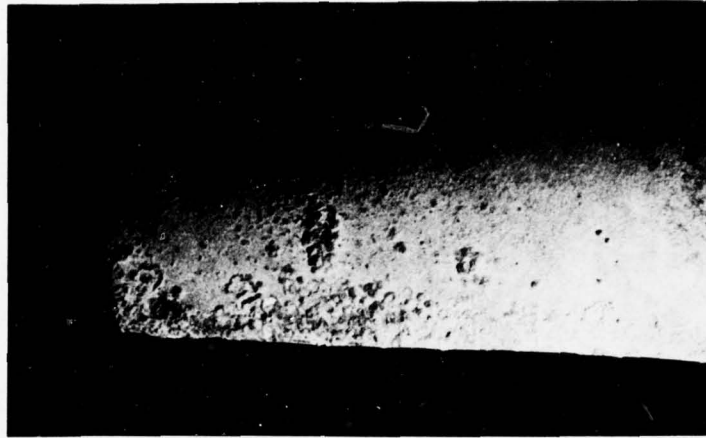
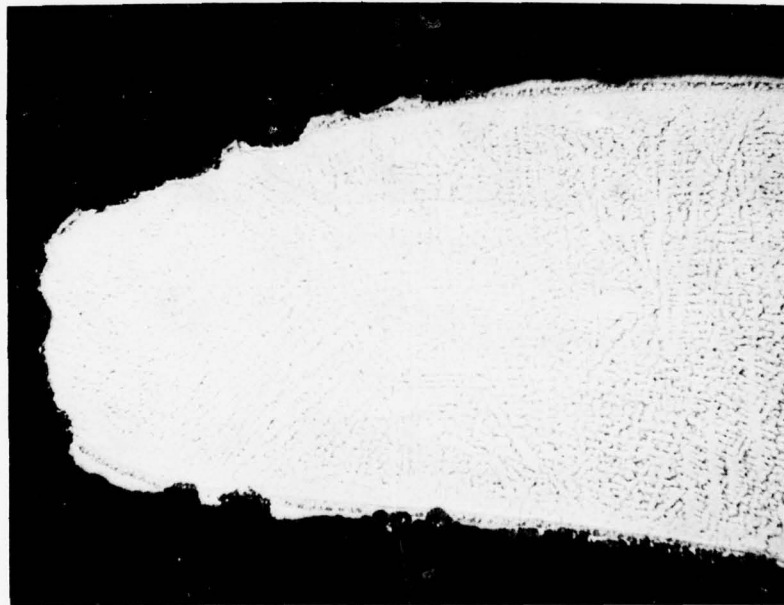
Surface condition of failed Alpak coated alloy 713C
after 400 cycles of hot corrosion testing

Photomicrograph of section cut through corroded areas of the
upper airfoil showing the leading edge of blade

Figure 3-11 Hot corrosion attack on Alpak coated alloy 713C turbine blade
test specimen

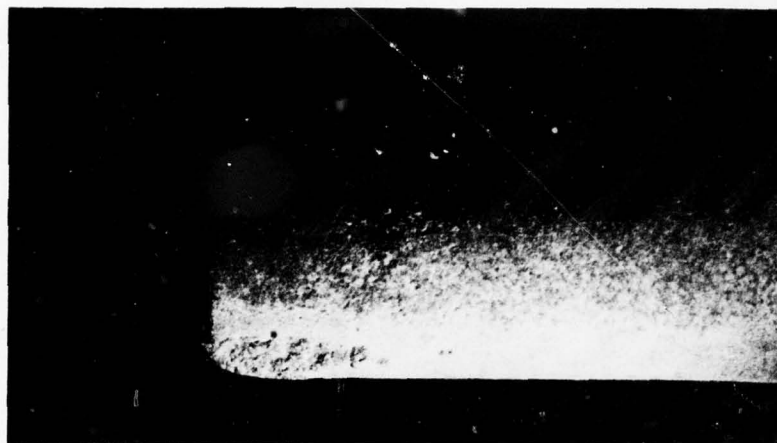
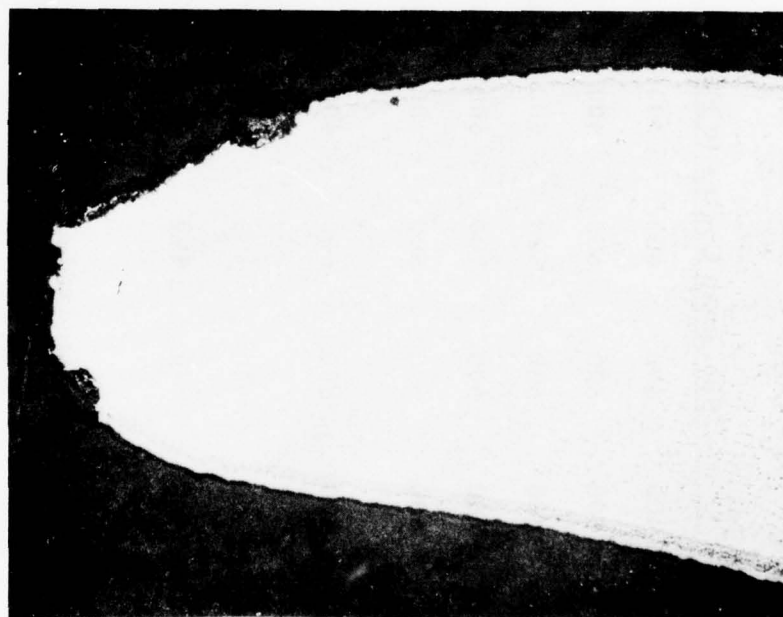
Surface condition of failed AEP 32 coated alloy 713C
after 600 cycles of hot corrosion testing

Photomicrograph of section cut through corroded areas
of the upper airfoil showing the leading edge of blade

Figure 3-12 Hot corrosion attack on AEP 32 coated alloy 713C turbine blade
test specimen

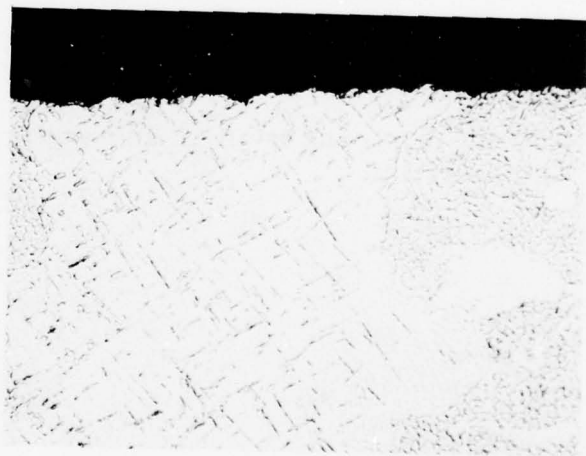
Figure 3-33

Alloy 713C/Alpak coated T56 1st Stage Turbine Blade, P/N 6876564, as received for recoating. (b) Photomicrographs illustrate typical airfoil surface condition before and after chemical stripping.

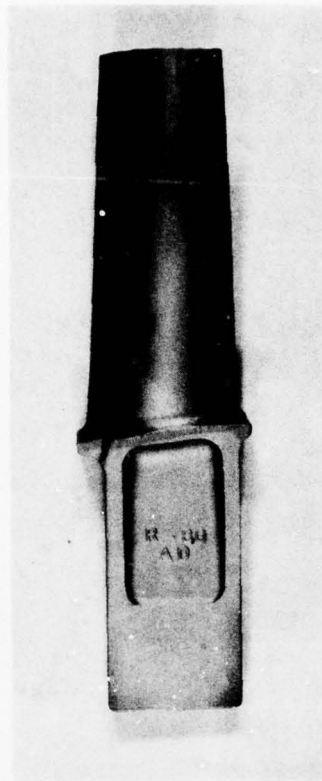
Figure 3-34

(a) Rene' 80/Codep B-1 coated J79 1st Stage Turbine Blade, P/N 11OR342PO3, as received.
 (b) Photomicrographs are typical of blades mid-airfoil surfaces before and after chemical stripping.

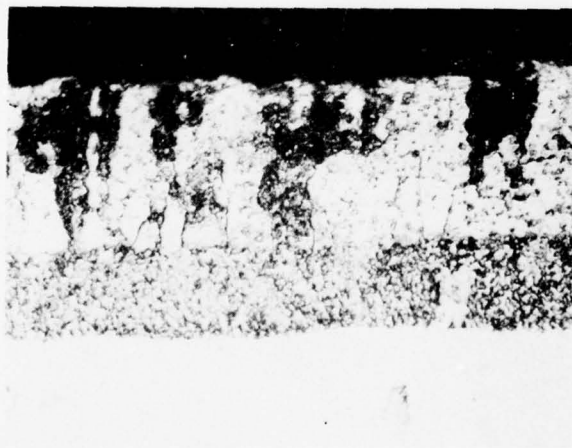
Figure 3-35

(a) B1900/PWA 73 coated F100 1st Stage Turbine Blade, P/N 4039571, as received for recoating. (b) Photomicrograph illustrates typical airfoil surface condition before and after chemical stripping.
